Trail maintenance project report - Laugavegurinn (summer 2014)
Partnership project with The Icelandic Mountain Guides

The aim of this project was to repair damaged sections of the Laugavegur trail between the Þröngá river and Emstrur. Sites were chosen close to Slyppugil and work began on the trail approximately 10km north of Langidalur. The sections of the trail that went through deep soil areas were the most damaged and these areas became the focus for this year's work. The work tasks included the removal of erosion scars, improvement to drainage and the restoration of damaged vegetation. Several secondary trails were closed with ropes to reduce trampling.

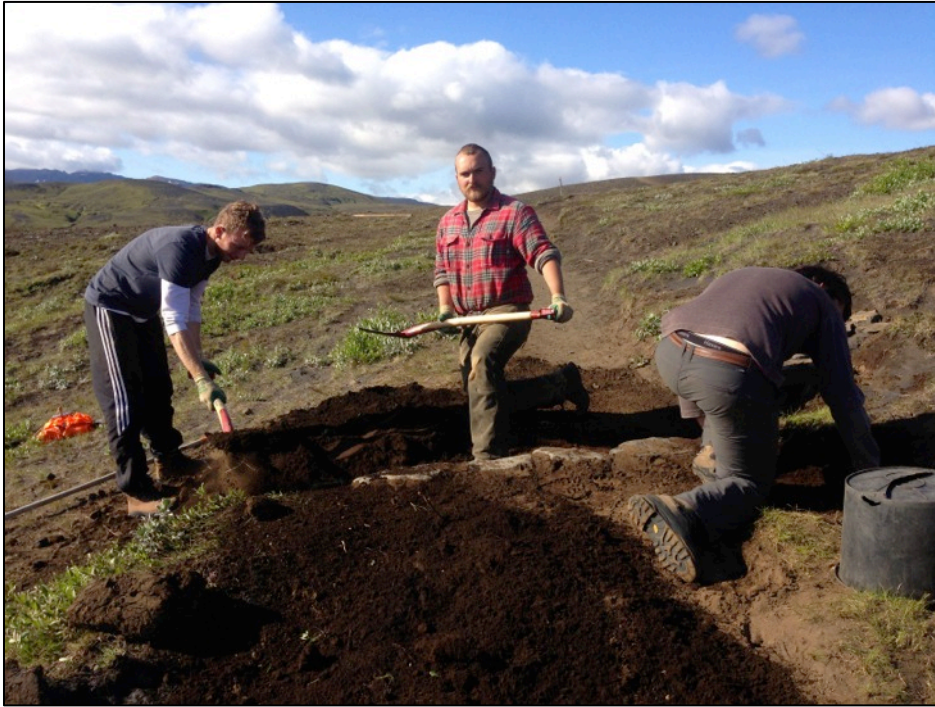
Stone water bar construction

Improving drainage – Stone water bars were constructed in several locations to remove surface water on the trail. These were sighted above slopes to protect them from the effects of water erosion. Where possible, existing ditches and natural drains were used to channel water from the trail.

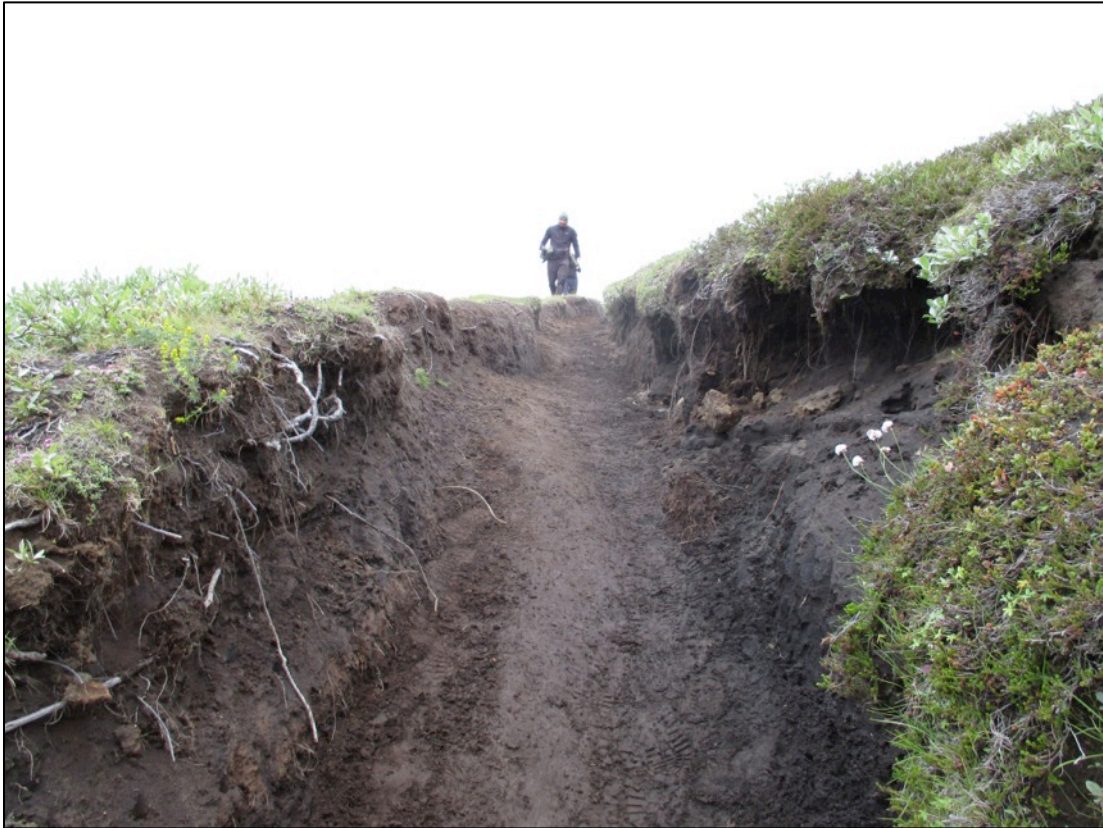
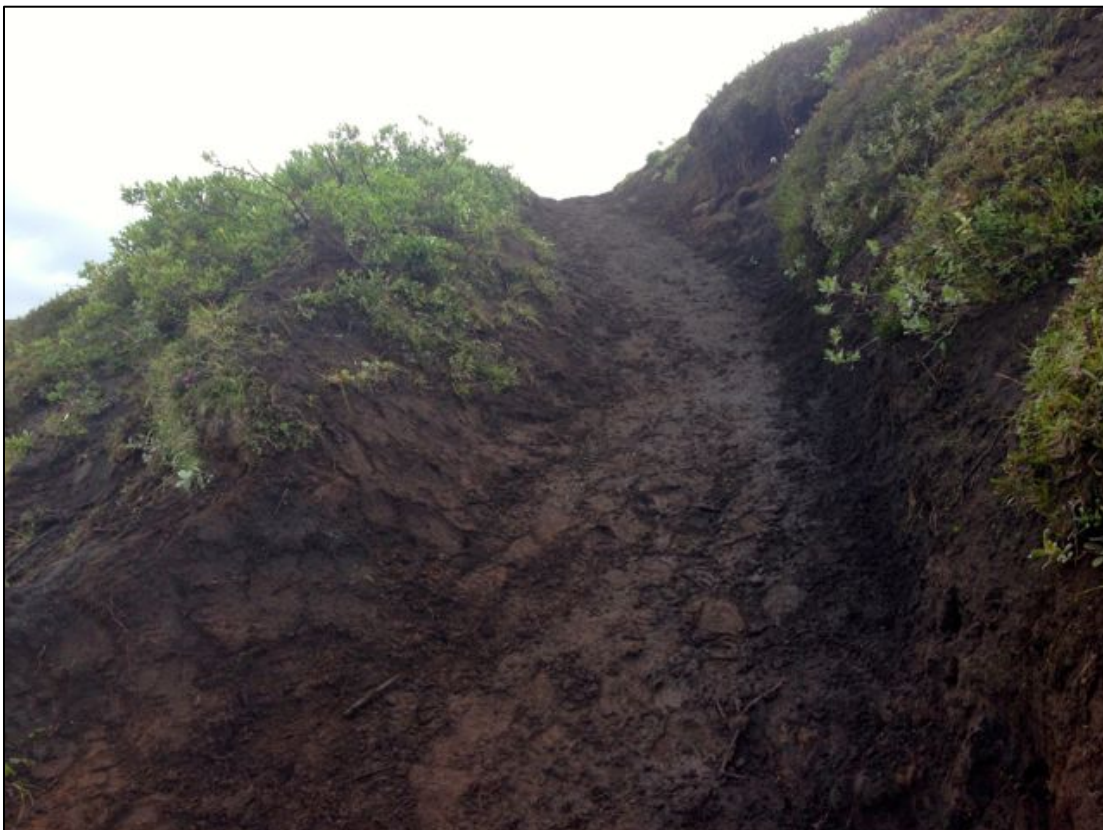
(Before and after) Undercutting and reprofiling of the slope. Remaining vegetation is replanted to cover exposed roots and establish a growing surface. A small amount of fertilizer is added to promote regrowth.

Undercutting – In many of the deep soil sections of the path, erosion has lead to undercutting the existing vegetation and exposing the roots. In many places, repair work involved simply undercutting the existing vegetation, reprofiling the banks and replanting. This is an effective method for stabilising the banks.

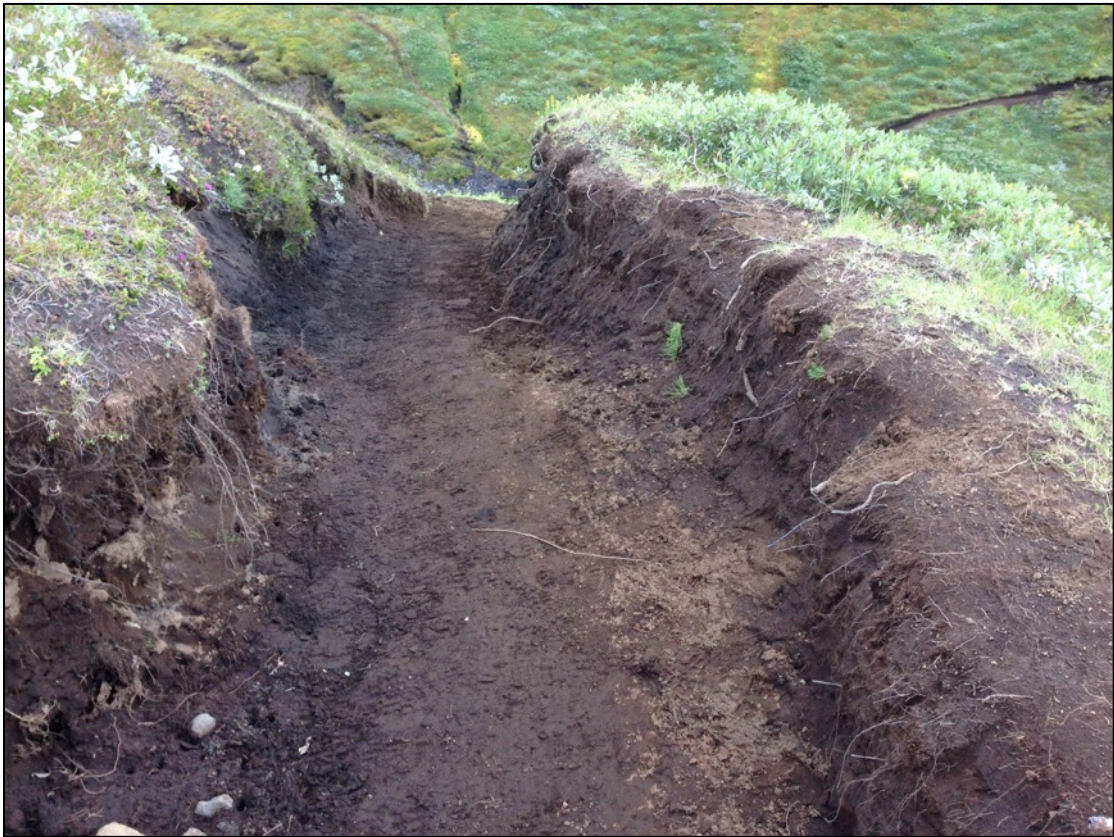
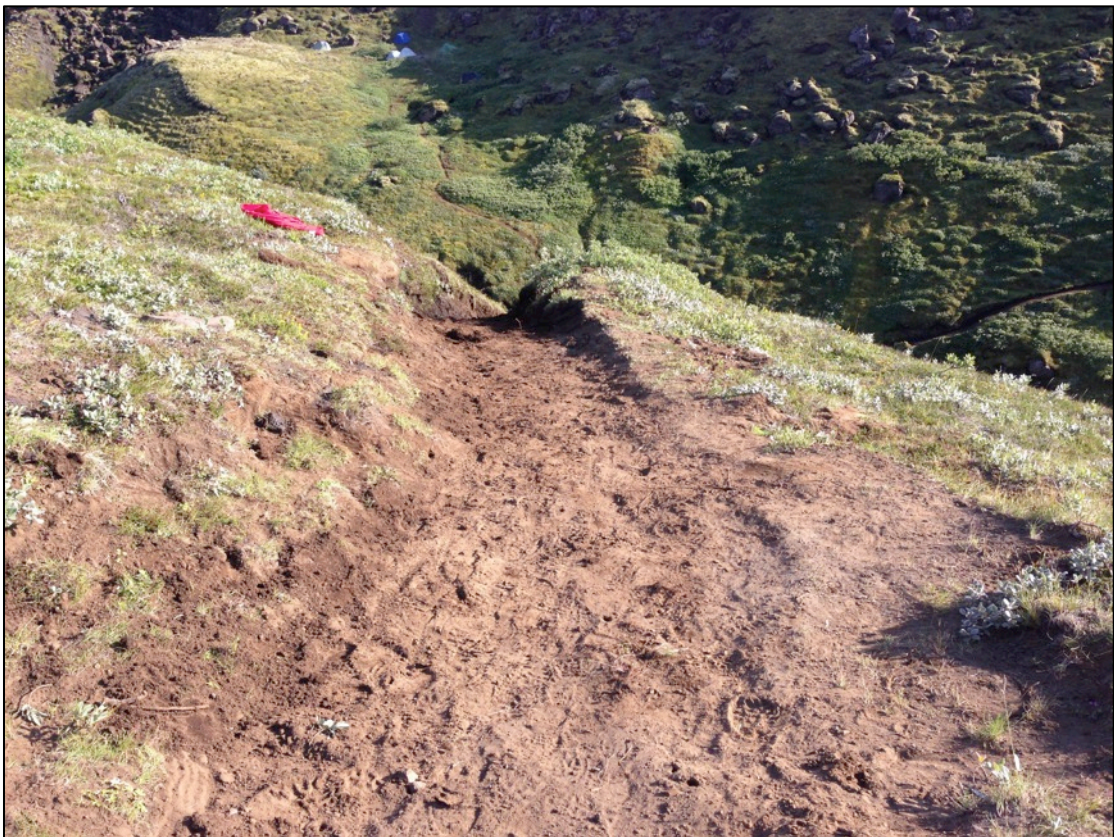
(Before and After) Reprofiling and filling the gullied trail. Stone waterbars were constructed upslope to prevent further damage from water.

Repairing gullying – Areas beside the trail were filled and reprofiled. Stone and sand was used for filling and soil was added to create a growing surface. Ryegrass seed and a small amount of fertilizer were added to speed up revegetation and protect the areas from further erosion. Areas on the path were filled with stones and resurfaced with gravel and sand to establish a strong walking surface.

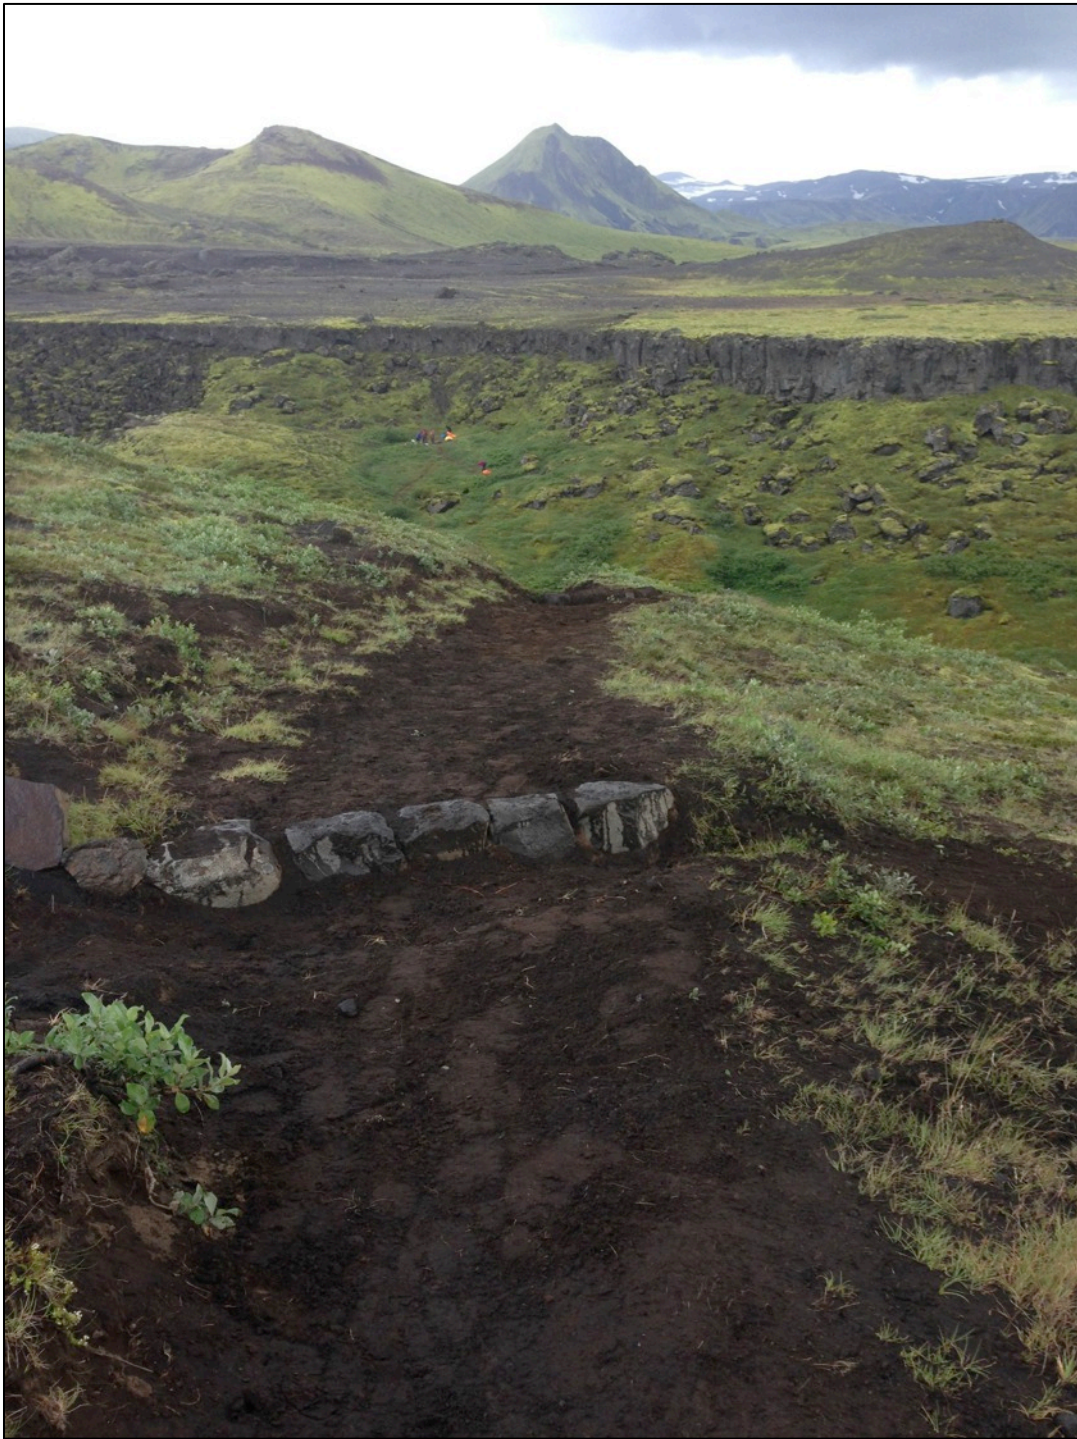
(After) Stone waterbar build to protect the repaired trail and slope ahead. The left side of the trail has been regarded where the bank has been undercut and filled. Turf has then been replanted.

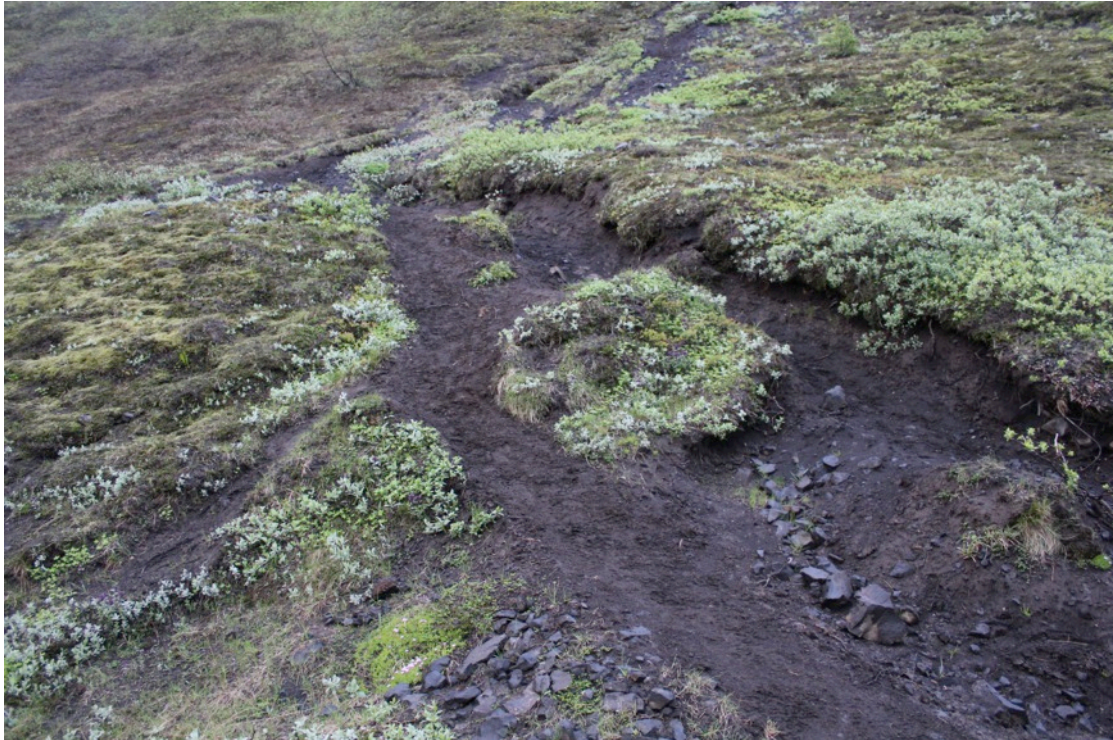
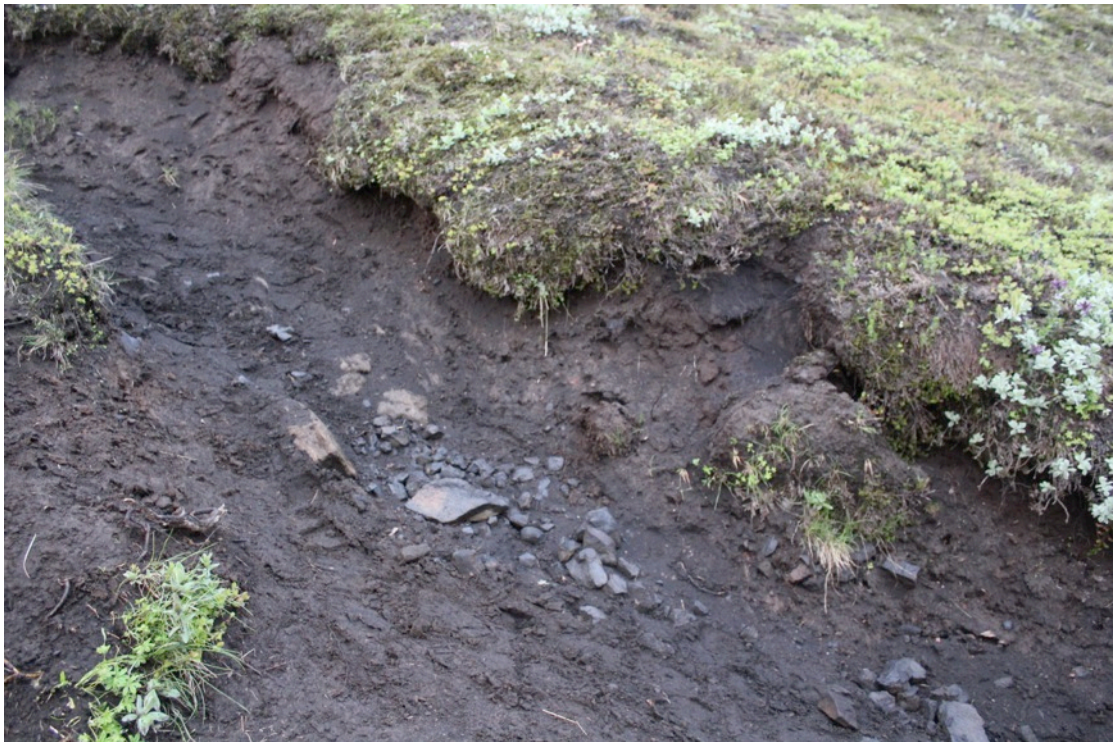
(Before) Badly eroded area showing secondary trails.

Removing secondary trails – In several areas, secondary trails were removed. Areas were reprofiled and seeded with ryegrass. Temporary ropes were used to close these areas to prevent trampling and allow the vegetation to recover.

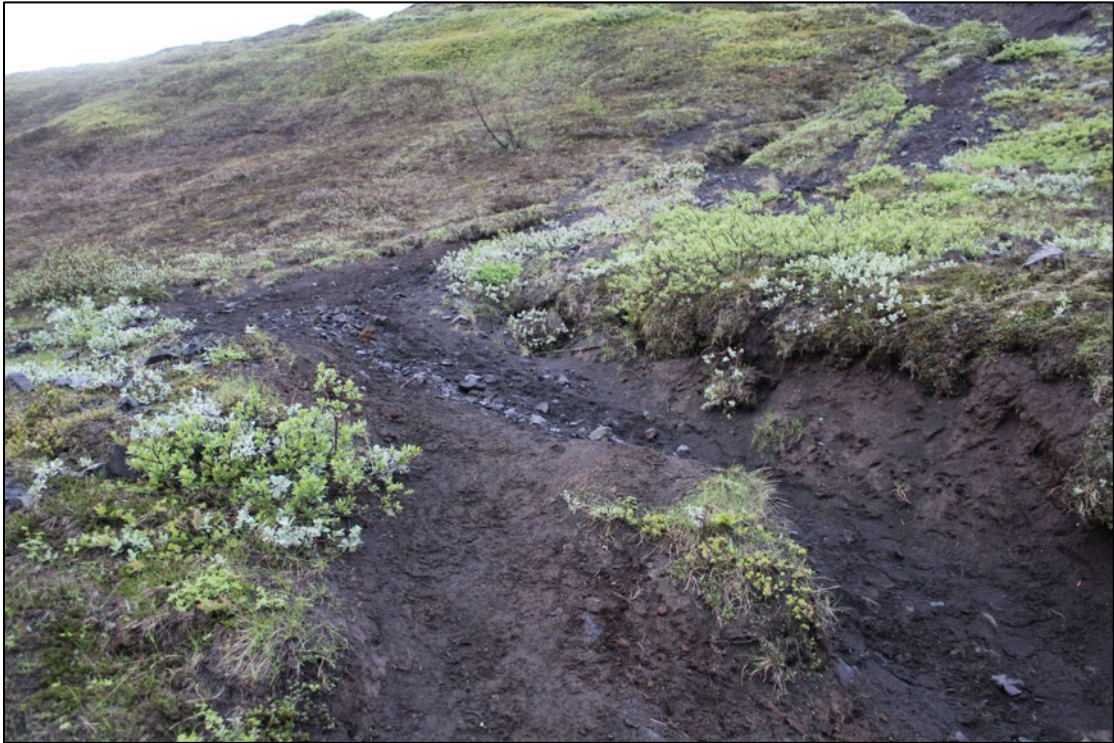
(Before) Secondary trail eroding and becoming a gully.

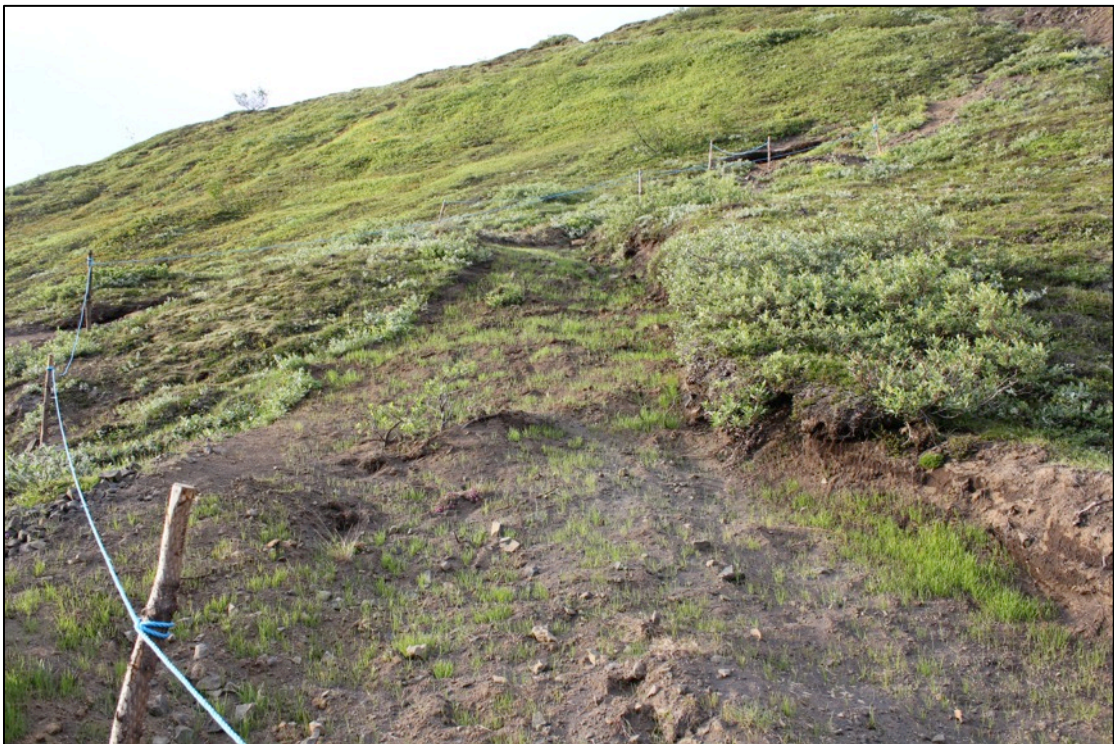
(After) Erosion gully filled with stone, covered with soil and planted with ryegrass.

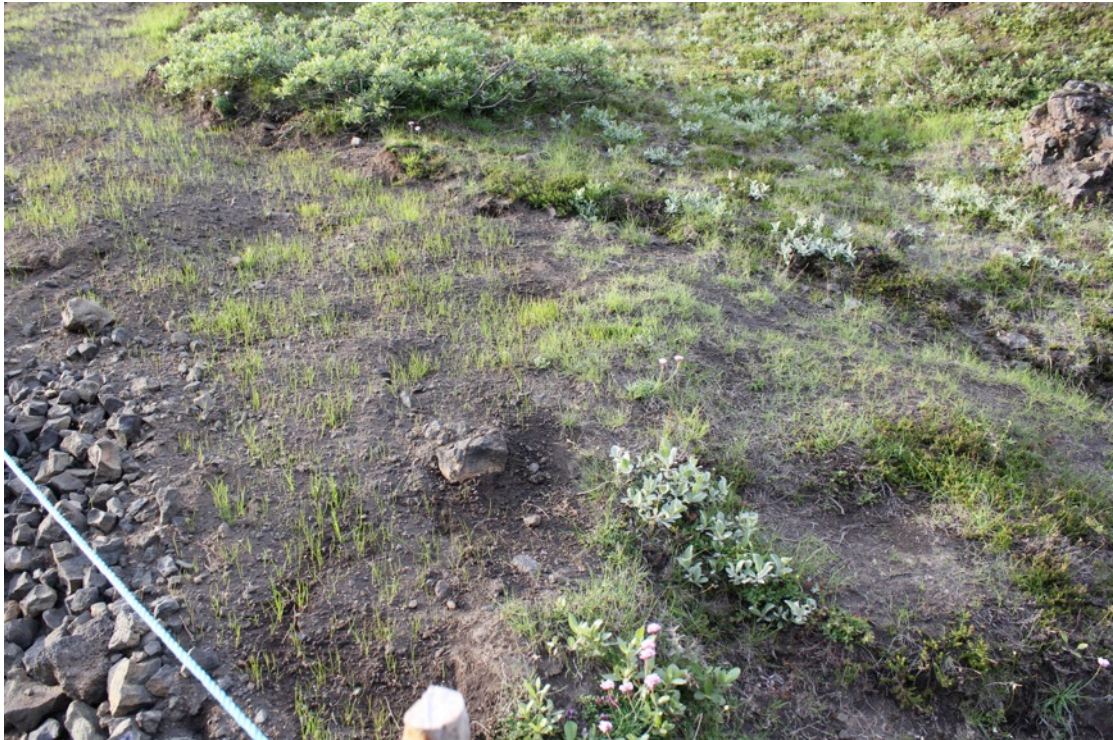
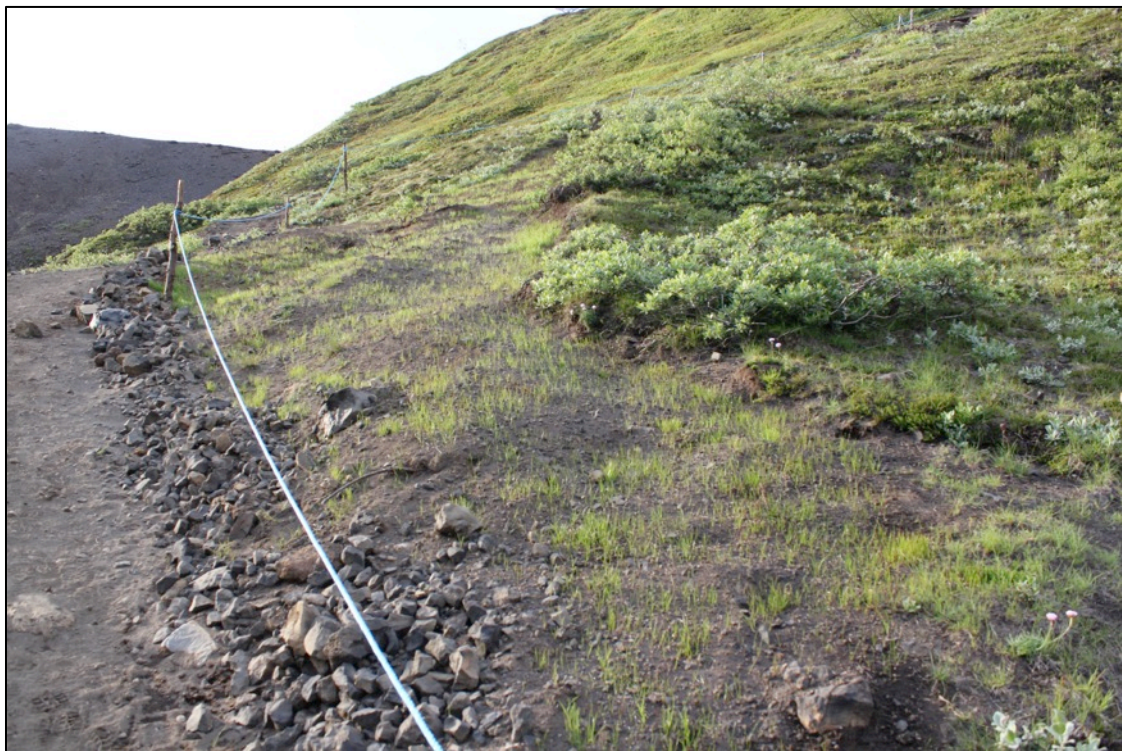
(After) Site reprofiled and planted with ryegrass. On several sections temporary ropes were added to prevent trampling and encourage regrowth.

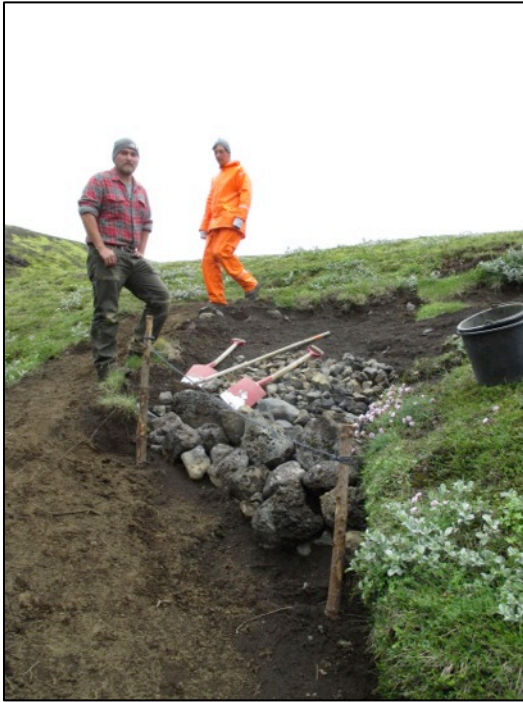
(During) Stone added to eroded area.

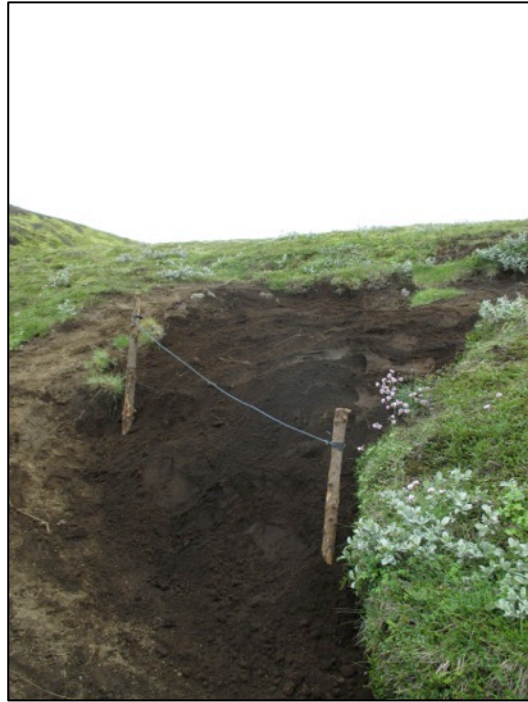
(After) Soil and ryegrass seed added.
